# Manhole Inspection Summary

Manhole # S27E\_\_019MH

Insp Date: **5/26/09 3:30 PM**

**Location** Address: **1003 LEXINGTON ST**

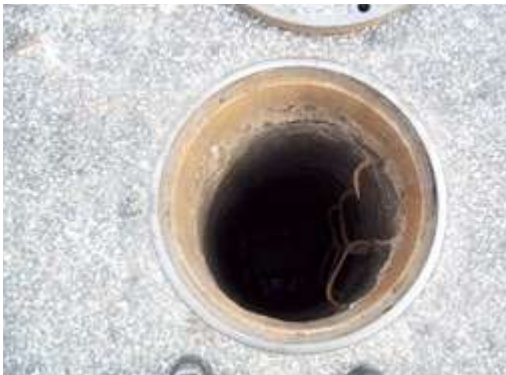
Defect 2

Offset: **1** (in.)

Count: **16** Missing: **1** ☒ **Corroded**

CORRODED STEPS, MISSING 1, FRAME OFFSET

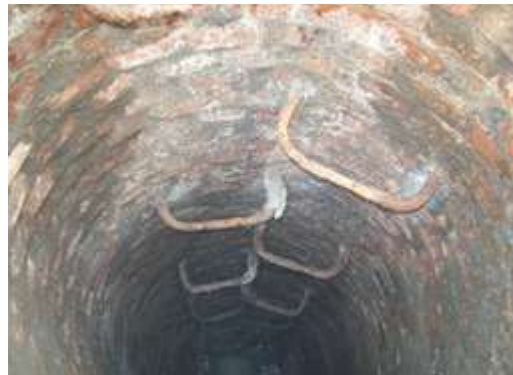
Defect 1

☒ **Evidence Of Surcharge** Depth: **12** (ft.) ☐ Active Surcharge Present

EVIDENSE OF SURCHARGE

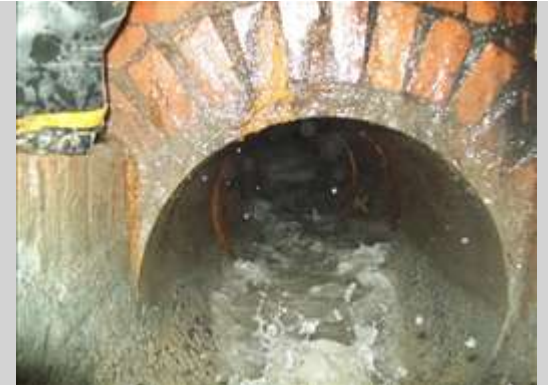
12 O'Clock Outflow

21 in. Circular Gravity Sewer  
Pipe Out @ 12 O'Clock

Pipe Height: (in.) Direct  
Pipe Material: **Clay** ☐ Pipe Lined  
Invert Depth: **22.56** (ft.) Flow Characteristics: **Fast**  
Deposits: ☒ None ☐ Mud ☐ Sludge ☐ Debris ☐ Grease  
Silt Depth: (in.) Deposits Extent:  
Infiltration: **None** Pipe Seal Cond: **Sound**

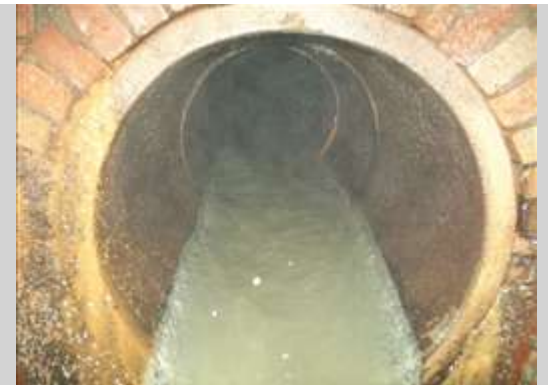
6 O'Clock Inflow

21 in. Circular Gravity Sewer  
Pipe In @ 6 O'Clock

Pipe Height: (in.) Direct  
Pipe Material: **Concrete** ☐ Pipe Lined  
Invert Depth: **16.52** (ft.) Flow Characteristics: **Fast**  
Deposits: ☒ None ☐ Mud ☐ Sludge ☐ Debris ☐ Grease  
Silt Depth: (in.) Deposits Extent:  
Infiltration: **None** Pipe Seal Cond: **Sound**

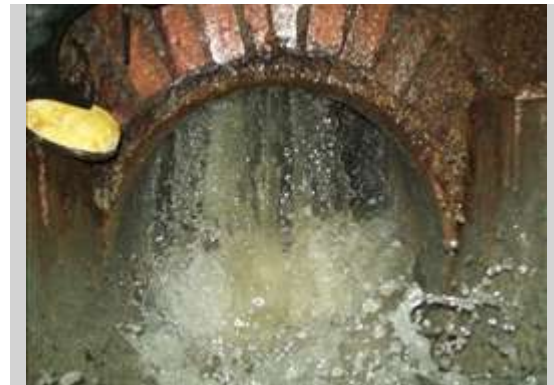
Drop In @ 6 O'Clock

Drop: **Inside** **Direct**  
Angled: Reading: (ft.)  
Inv Depth: **22.34** (ft.)

Drop Condition: **Open**

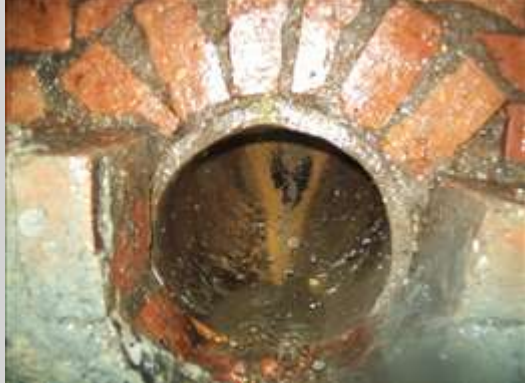
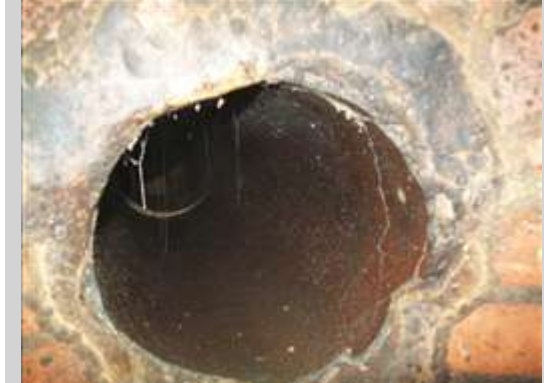
9 O'Clock Inflow

8 in. Circular Gravity Sewer

Pipe In @ 9 O'Clock

Drop In @ 9 O'Clock

Infiltration: **None** Pipe Seal Cond: **Sound**

Drop: **Inside** **Direct**

Drop Condition: **Open**
